Manhole Inspection Summary

Manhole # S05EE2052MH

Location Address: **2806 STRATHMORE AVE**

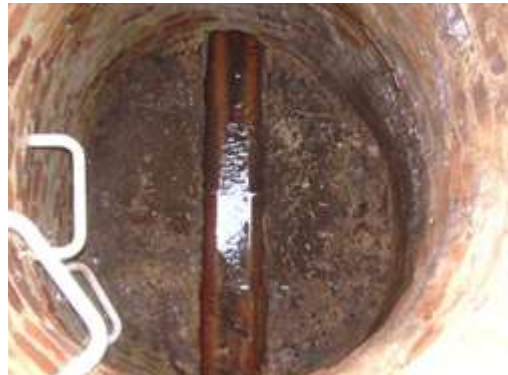
Top View

Evidence of surcharge - Bench debris.

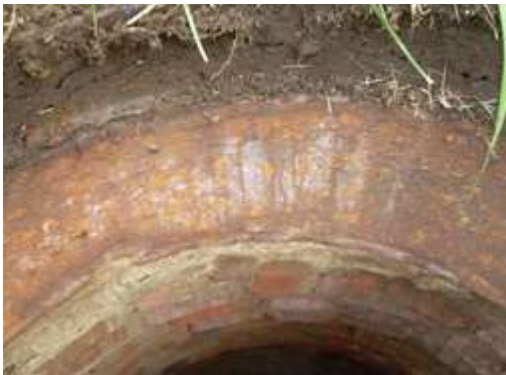
Defect

Frame leaks. Corbel and Barrel infiltration - other side.

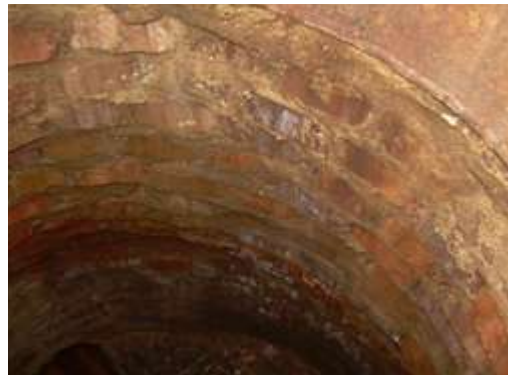
Defect

Frame leaks. Corbel and Barrel infiltration.

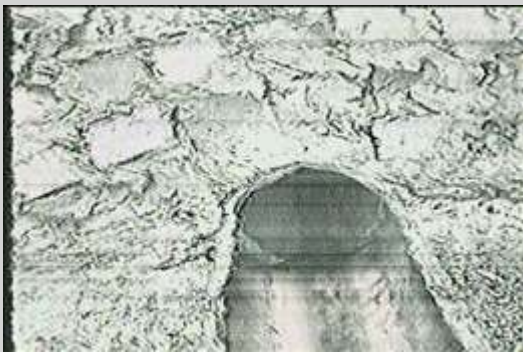
8 in. Circular Gravity Sewer Pipe Out @ 12 O'Clock

Barrel deterioration and infiltration.

Infiltration: **Evidence** Pipe Seal Cond: **Unknown**

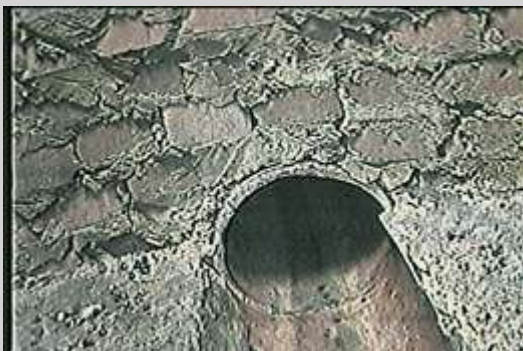
8 in. Circular Gravity Sewer Pipe In @ 6 O'Clock

Barrel deterioration and infiltration.

Infiltration: **Evidence** Pipe Seal Cond: **Broken**
